# Determination of Geotechnical Properties of Soil and Disaster Vulnerability Analysis

**Abstract**—This research aims to understand the factors and processes contributing to landslides by determining the geotechnical properties of soils and conducting numerical analyses of slope failures along the state highway in the eastern part of Mizoram, where Melbuk village is situated uphill of the study sites. This study employed geotechnical approaches and numerical analyses to determine the factor of safety. Due to toe-cutting for the construction and widening of the road, landslides triggered by rainfall occurred. Two landslides, at location 1 and location 2, were investigated where slope failure occurred down slope of Melbuk village. The stability of the slopes and probable landslide mechanisms were determined using various techniques, including limit equilibrium techniques, which evaluate the driving and resisting force equilibrium along possible failure surfaces. The Limit Equilibrium Method is extensively used in geotechnical engineering to assess slope stability and suggest remedial measures. From the Atterberg limit of the soil, it is observed that location 1 soil has silty-clay

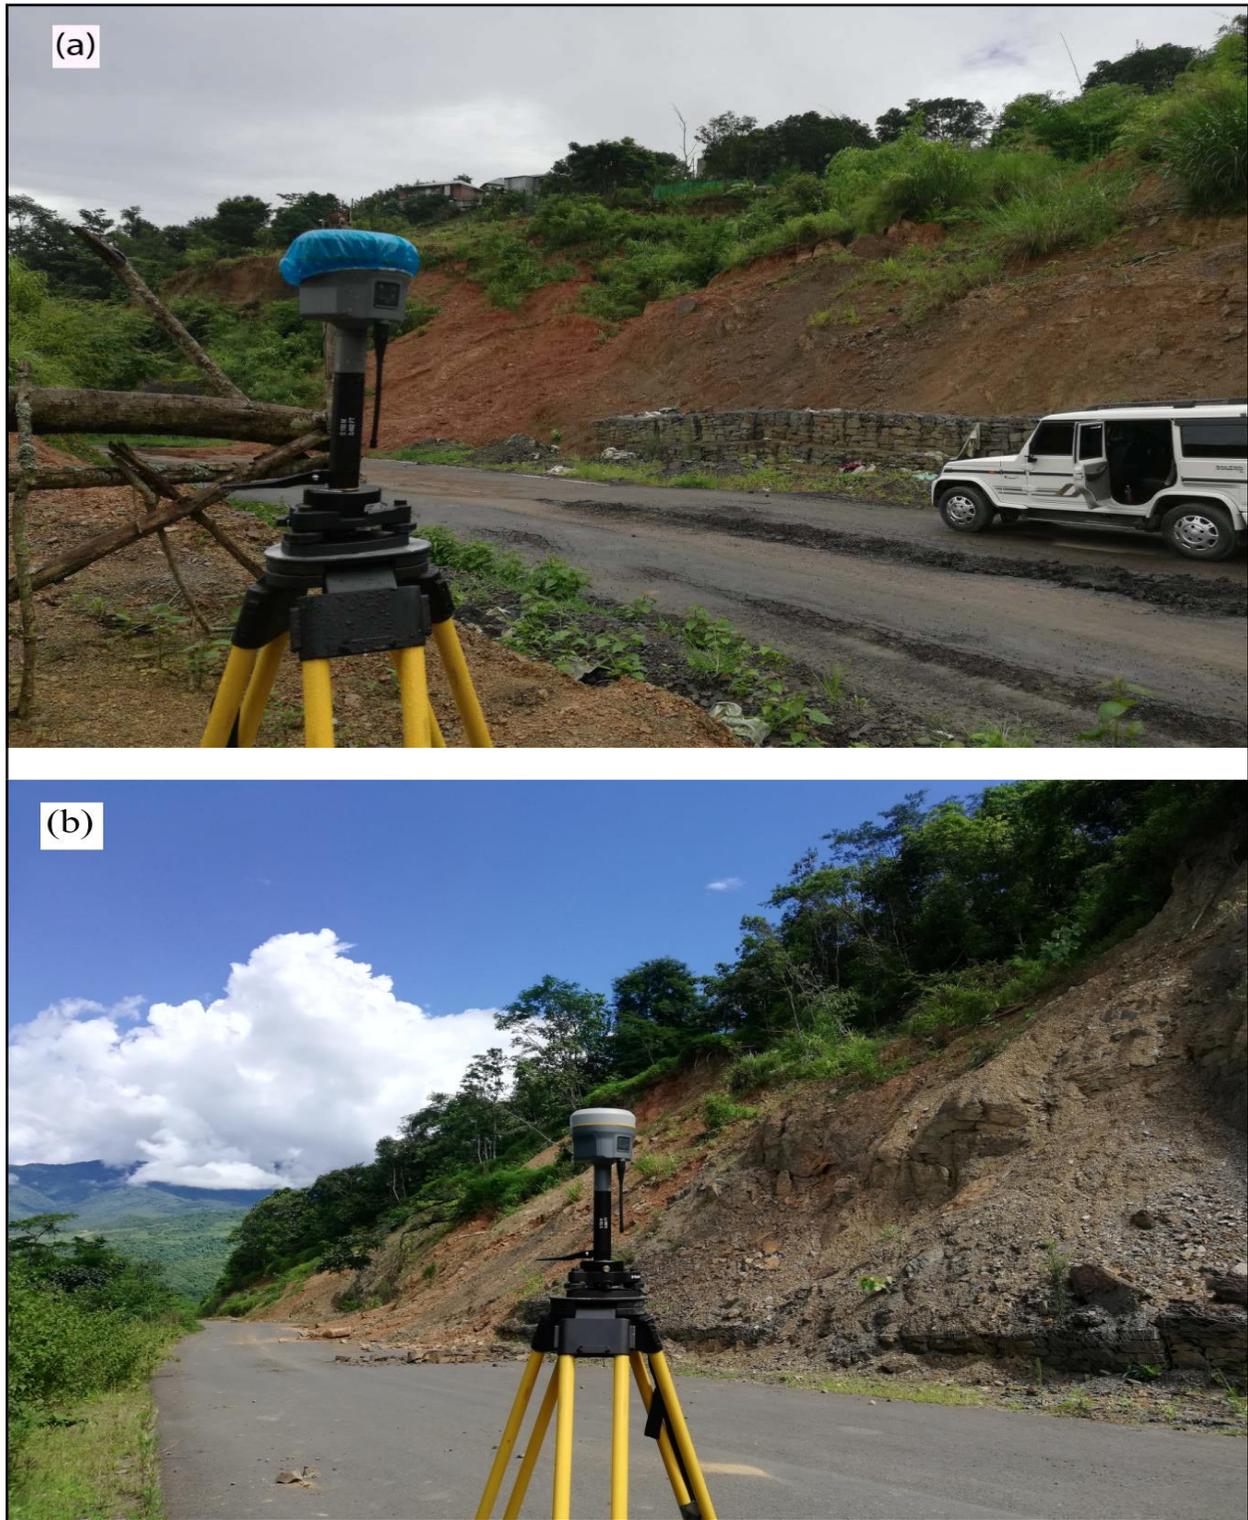
**Fig. 3: Field Photographs: (a) Location 1, (b) Location 2**

Field photographs (figure3) depict visual documentation of the study sites, where soil samples, geometry, and geology of the field were observed. The coordinates of the study sites were positioned using a differential global positioning system (DGPS).

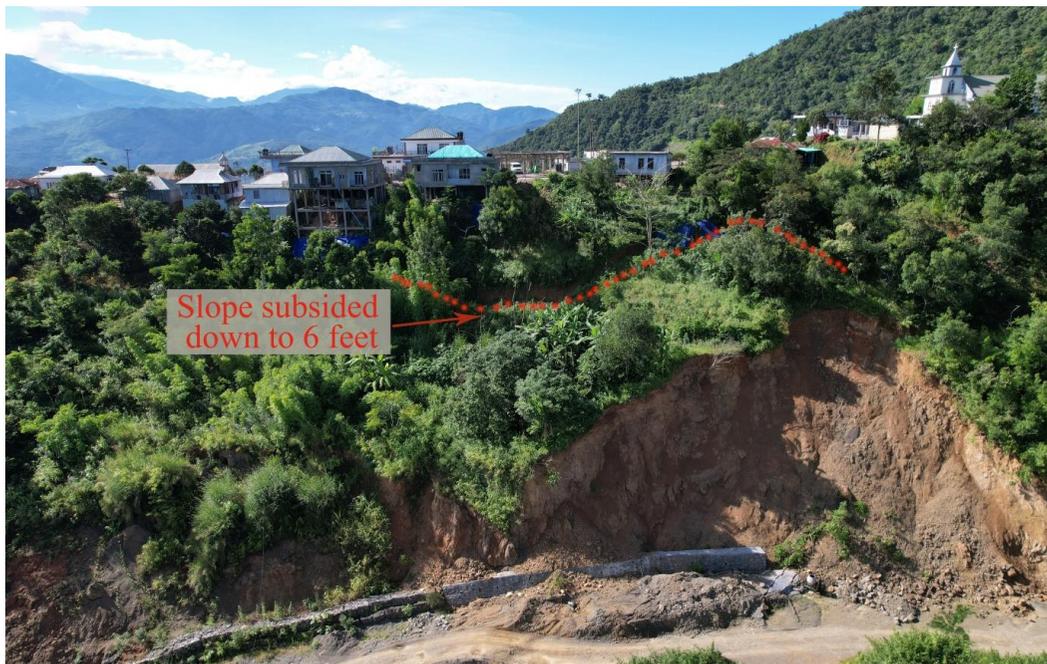
Fig. 6: Subsidence of Slope and Upward Movement at the Highway

Melbuk Village lies uphill of study sites and the route that connects it to Zokhawthar passes through the downhill of the village. The two locations were analysed using Rocscience software LEM 6.0 (figure 6 and figure 7), and the factor of safety for the two locations was determined. Based on the parameters obtained from the direct shear test; i.e., cohesion and angle of friction, the slope stability was analysed for location 1 and location 2 (table 3). The community has been impacted by these landslides, placing one church and five residential homes at risk of collapsing. It has been observed that location 1 has sunk to a depth of six feet (Figure 6).

Location 1 is an active debris slide caused by large-scale cut slope failure at the toe, comprising a reasonably thick overburden, mostly loose debris. The unchannelized water of domestic waste that penetrated the dense overburden decreased the cohesion of the soil. At the base of the landslide, gabion walls were built without the use of slope-easing techniques. A rotational sliding caused the asphalt to bubble up, causing damage to the road and some of the gabion walls. The impacted region measured roughly 62.2 meters in length and 100 meters in width. The average factor of safety of location 1 for different methods is 0.827.
